INDUSTRIAL HYGIENE ASSESSMENT

Wall Township Board of Education
1620 18th Avenue
Wall Township, New Jersey 07719

August 4, 2020
Partner Project Number: 20-286459.1

Subject: Mercury Investigation Services
Wall Township Board of Education
1620 18th Avenue
Wall, NJ 07719
Partner Project No. 20-283593.1

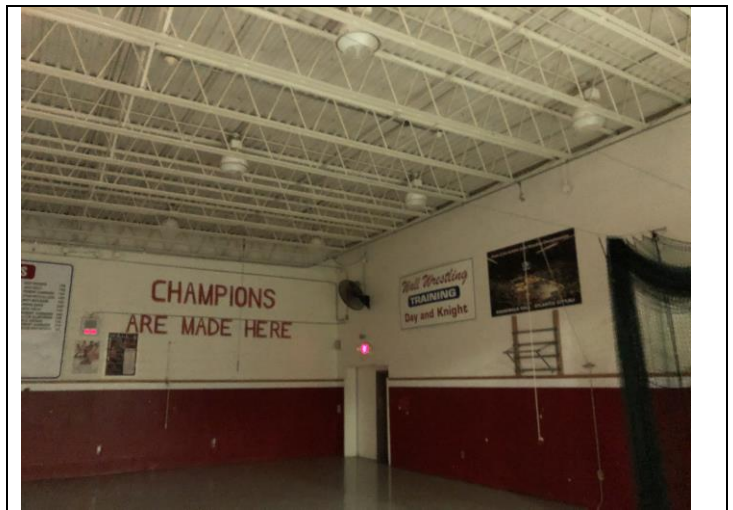
4. View of auxiliary gym.
